NIST NCSTAR 1-5E

**Federal Building and Fire Safety Investigation of the
World Trade Center Disaster**

**Experiments and Modeling of
Multiple Workstations Burning in a
Compartment**

Building and Fire Research Laboratory

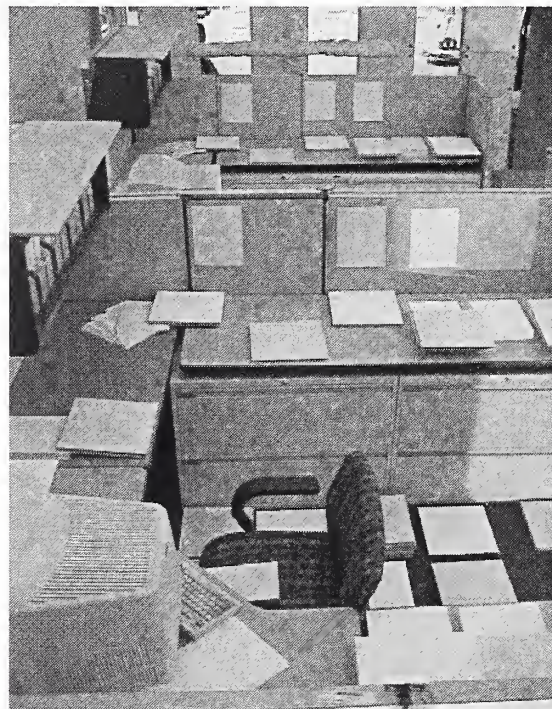
Figure 2–6. Image highlighting the arrangement of ceiling tiles used in Tests 3 and 4. The spray burner and compartment openings are visible towards the rear.

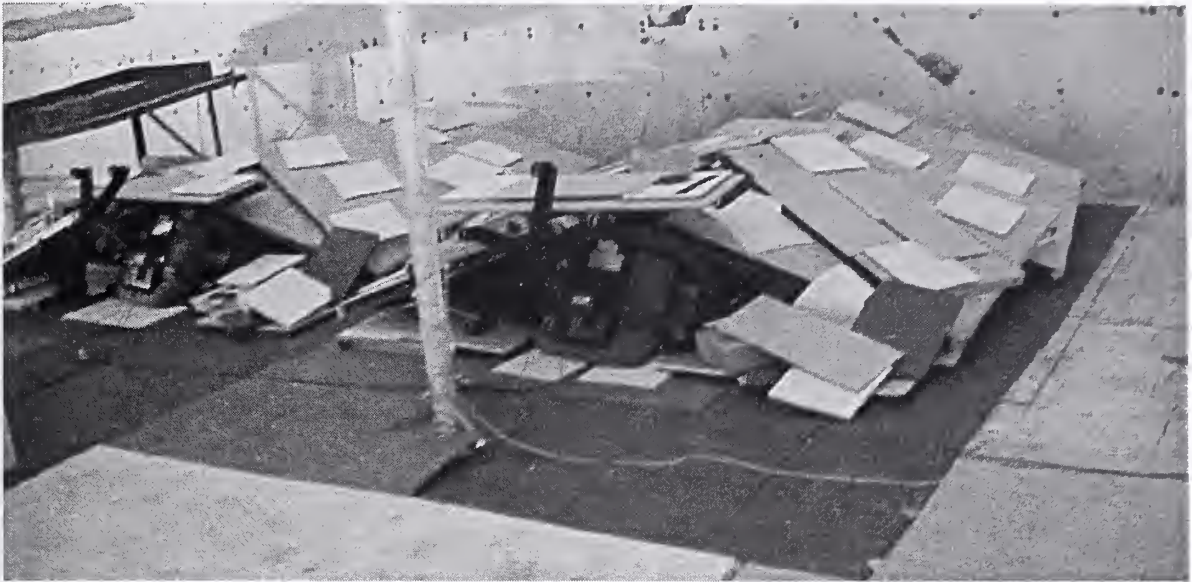
Figure 2-7. The arrangement of “rubblized” Workstations 1 (left) and 2 (right) with ceiling tiles before Test 5. Part of the spray burner is visible on the left.

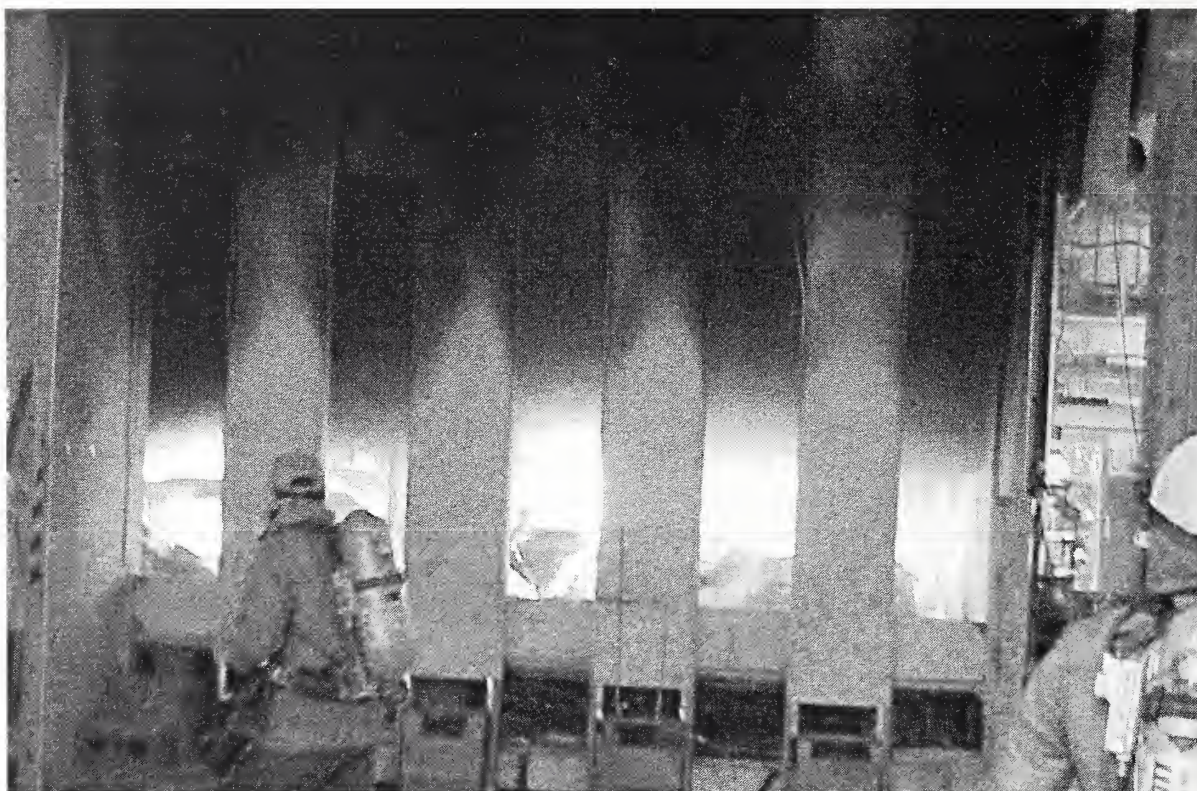
Figure 3–1. View of the fire compartment ½ min after the start of Test 5.

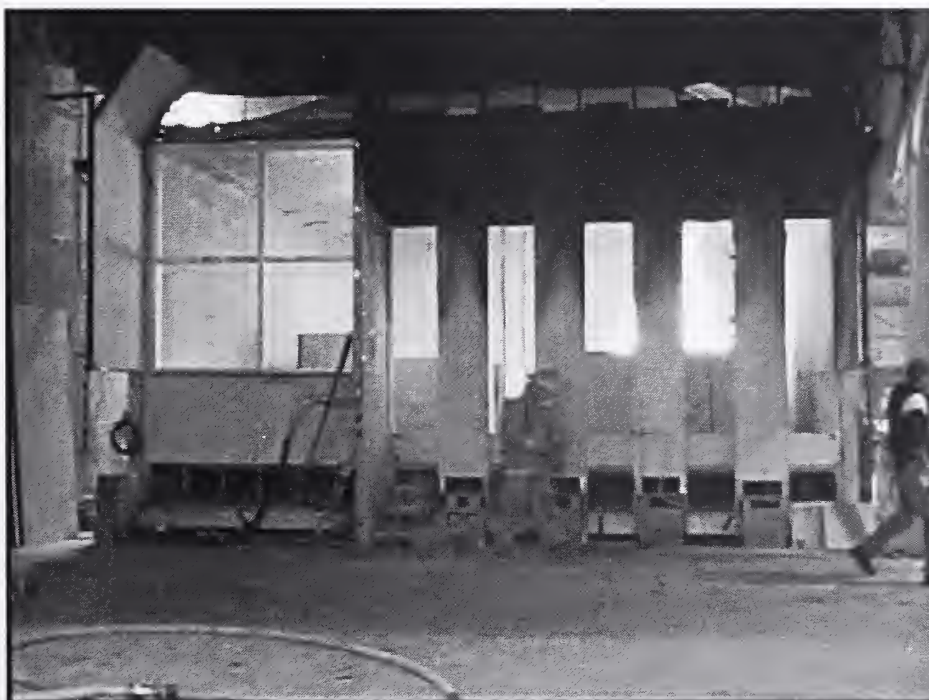
Figure 3–7. View external to the compartment 30 s before ignition of the spray burner in Test 6.

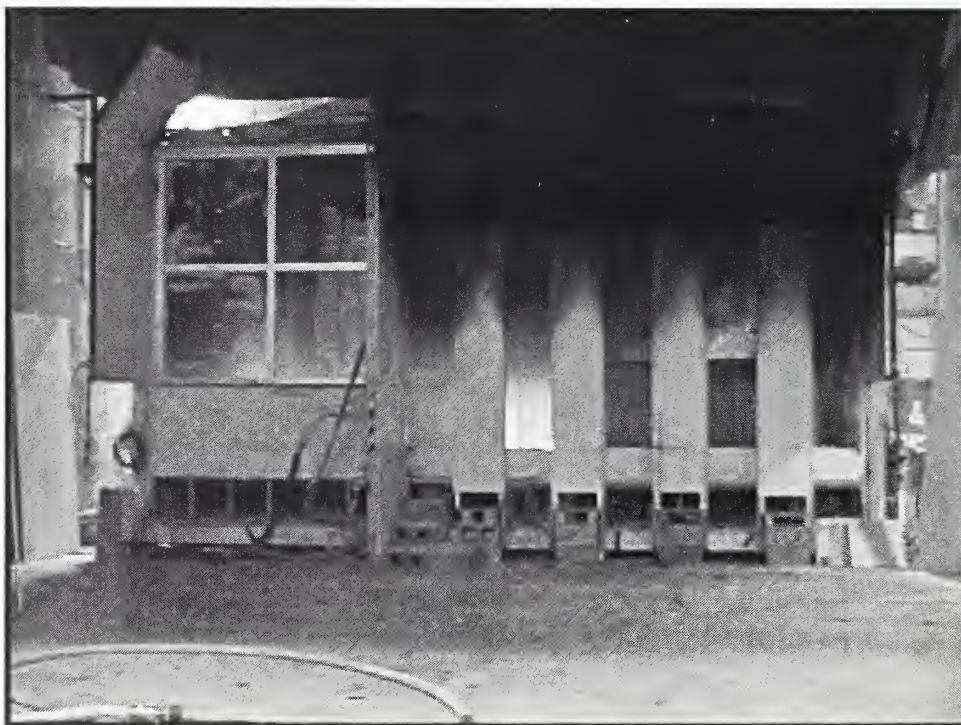
Figure 3–9. View external to the compartment 5 s after ignition of the spray burner in Test 6.

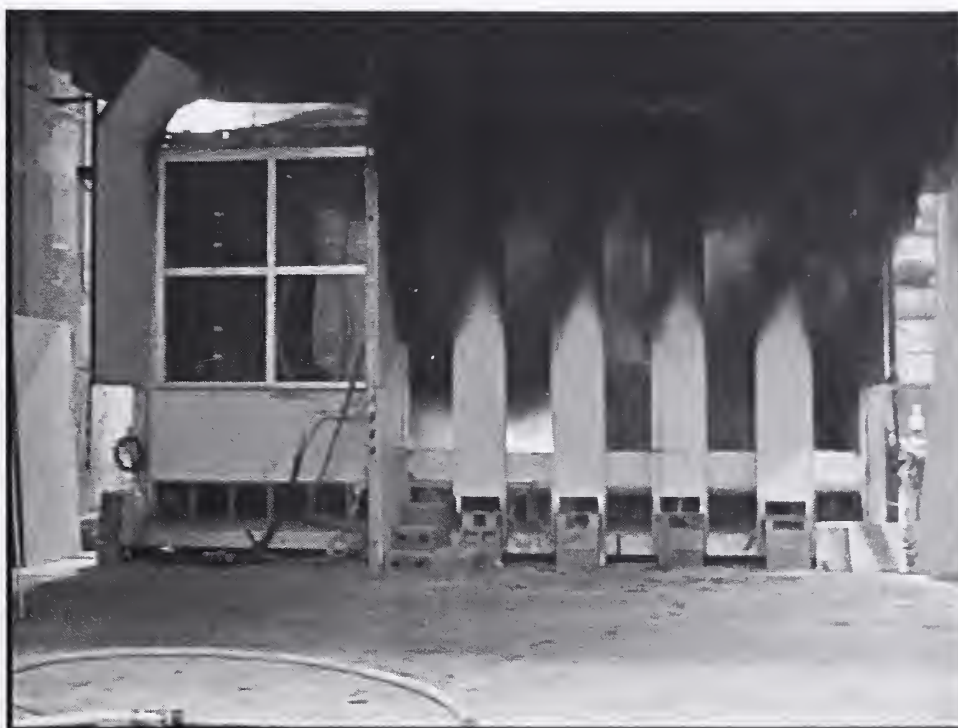
Figure 3-10. View external to the compartment 30 s after ignition of the spray burner in Test 6.

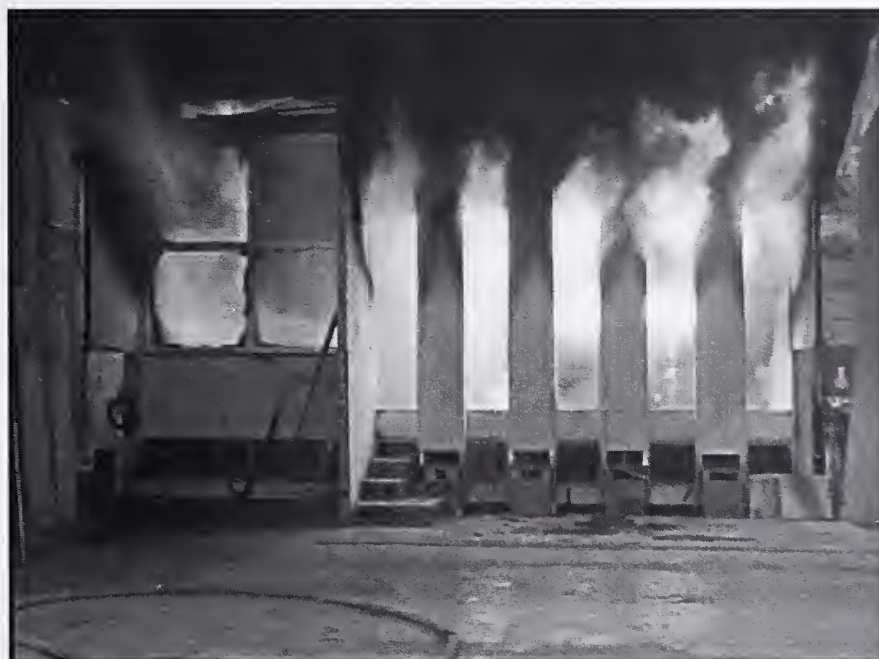
Figure 3-11. View external to the compartment 4 min 30 s after ignition of the spray burner in Test 6.

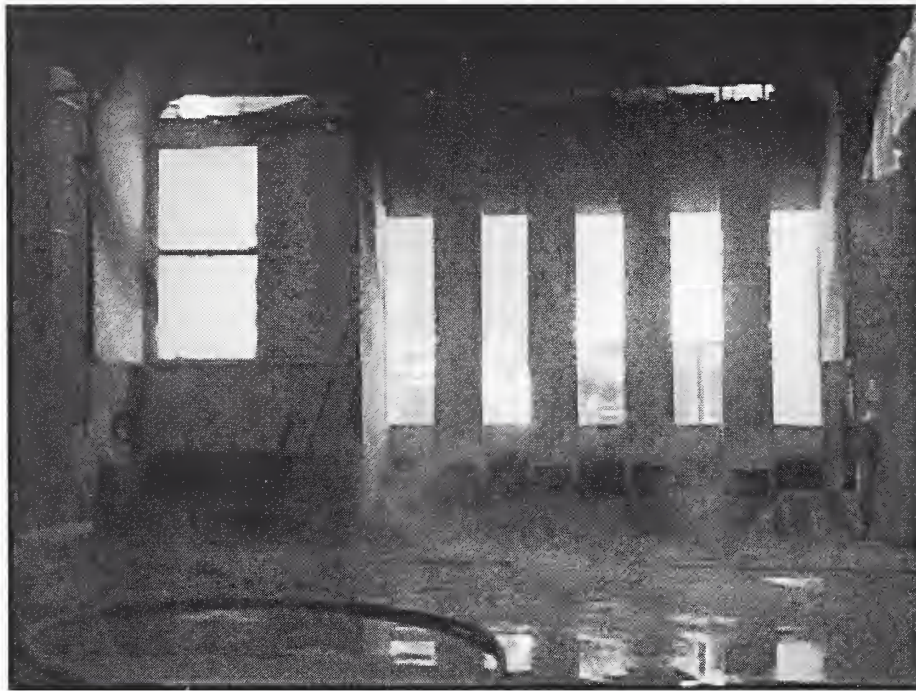
Figure 3-12. View external to the compartment 9 min 30 s after ignition of the spray burner in Test 6.

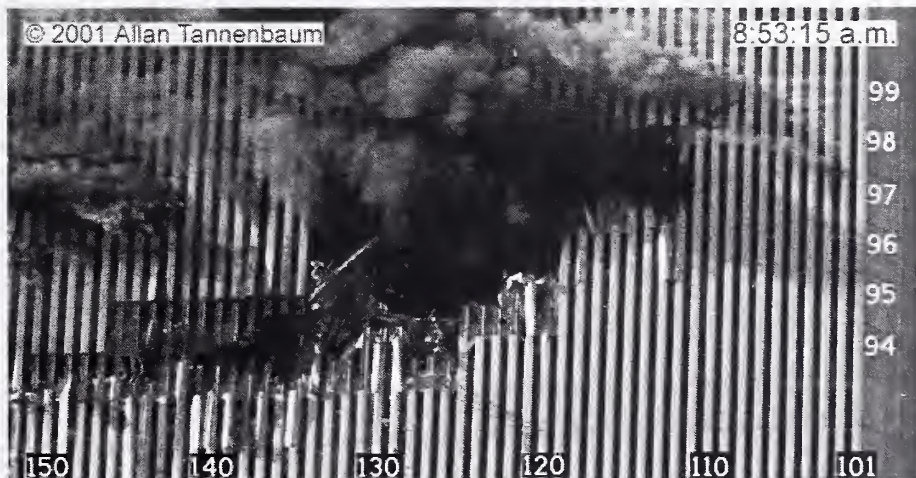
Figure 3–14. Photograph of the north face of WTC 1 recorded at 8:53:15 a.m. on September 11, 2001. Labels showing floor and column numbers were added to the original photograph.

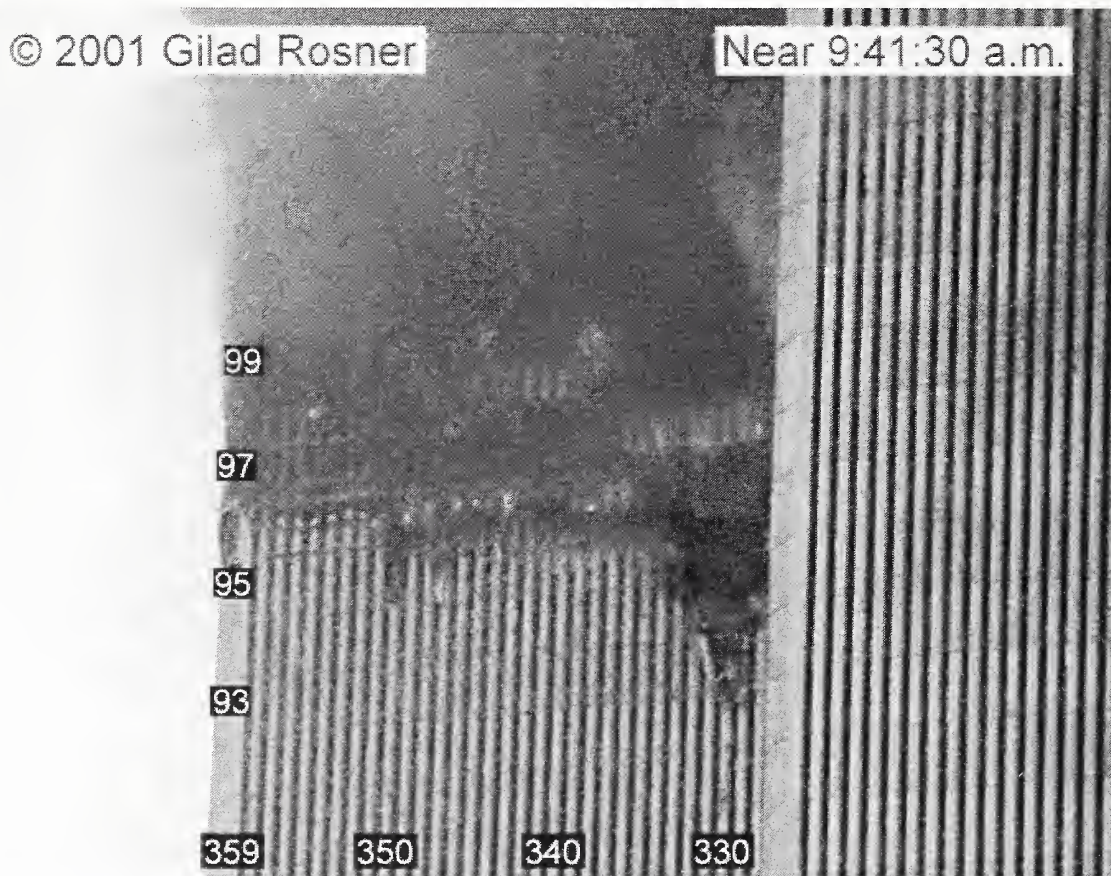
Figure 3–15. Photograph of the south face of WTC 1 taken at approximately 9:41:30 a.m. on September 11, 2001. Column and floor numbers were added to the original photograph.

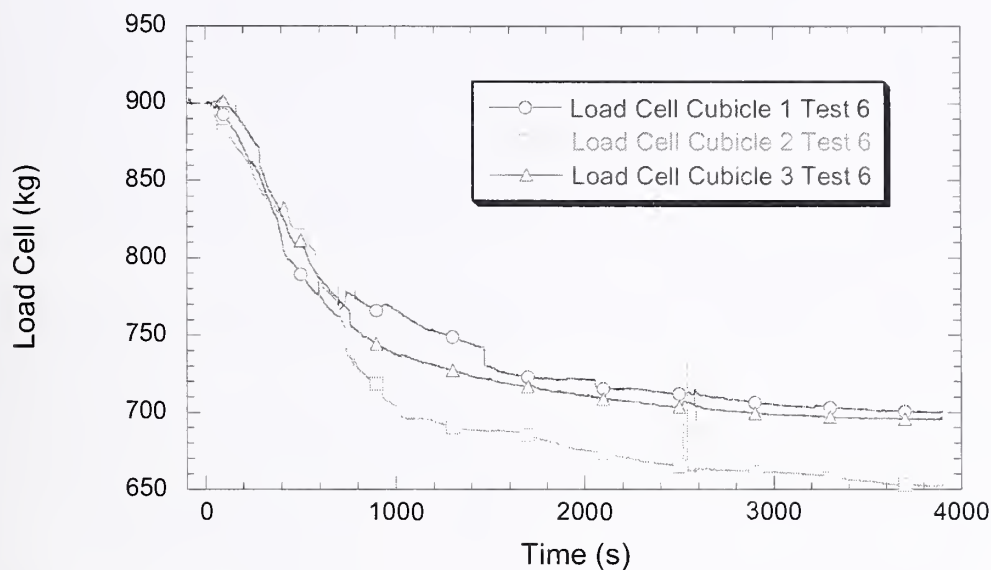
Figure 4–6. The mass of Workstations 1, 2, and 3 as a function of time during Test 6.
